# ***WATER OPERATION AND MAINTENANCE***

**BULLETIN NO. 146**

December 1988

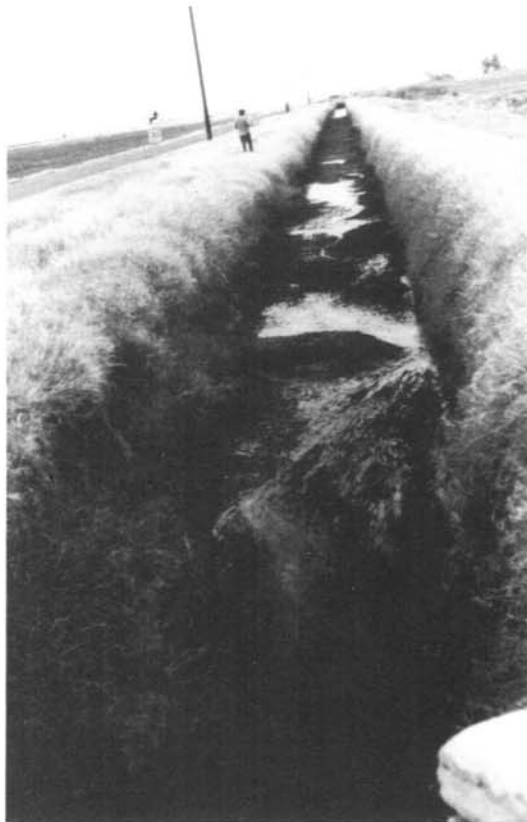
Figure 1. - A lateral canal is clogged with hydrilla which severely restricts the waterflow.

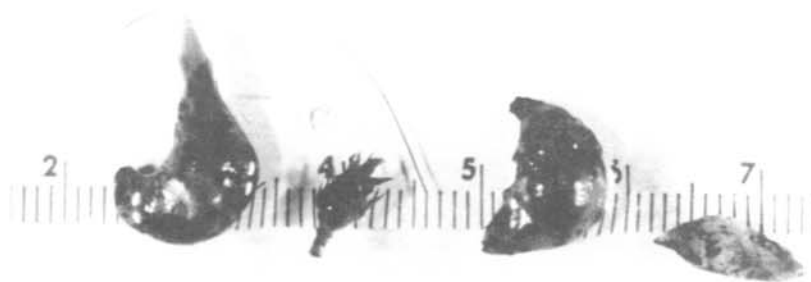
Figure 3. - These hydrilla tubers and turions (second from left) enable the weed to survive long winters or dry periods. The tuber on the left has germinated (ruler in millimeters).

Once the hydrilla plants formed tubers, they were harvested and studied for their germination characteristics. It is well documented that hydrilla tubers can remain in the soil for up to 10 years before conditions are right for them to germinate. Under ideal laboratory conditions, some tubers germinate within a few days, while other tubers will not have germinated after 6 months. Several vernalization techniques were investigated to determine what condition has to be met before germination occurs.
